# LACING VERSUS STIRRUPS - AN EXPERIMENTAL STUDY OF SHEAR REINFORCEMENT IN BLAST-RESISTANT STRUCTURES

Stanley C. Woodson

March 1992

Technical Report SL-92-2

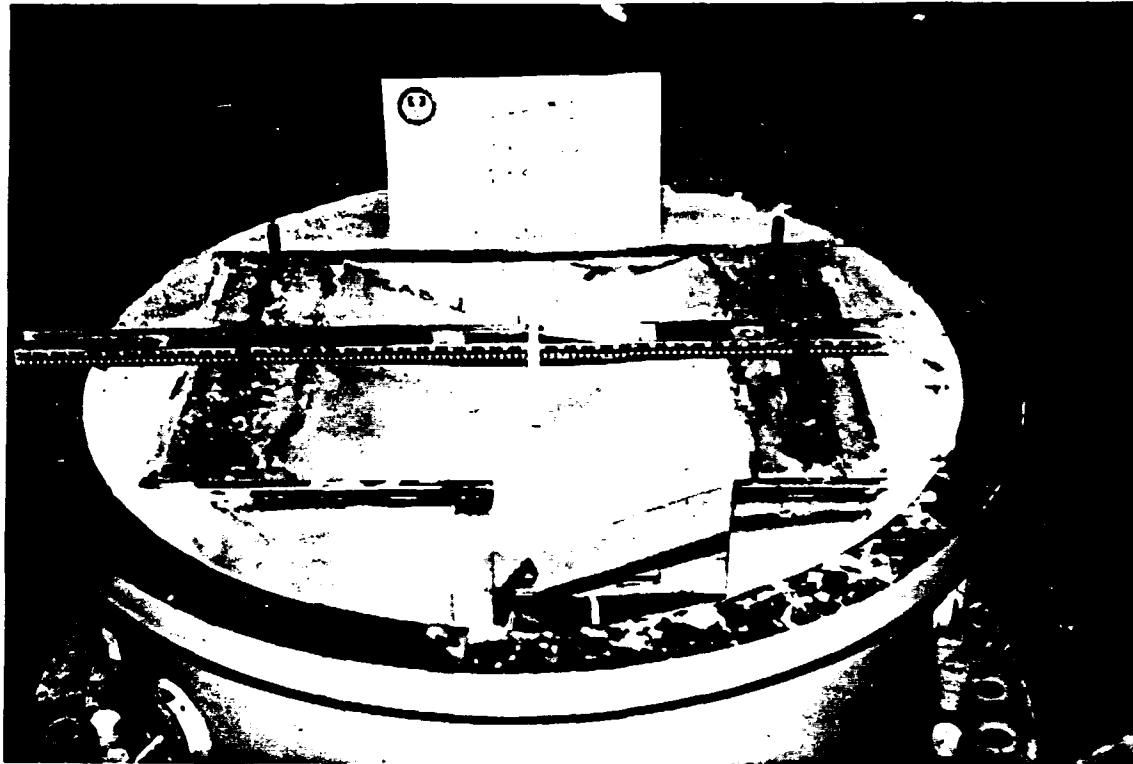
Figure 3.1. Posttest View of Slab No. 1

40. Since the objective of the study is to investigate the effects of shear reinforcement (particularly that of stirrups and lacing bars) on slab behavior, the slabs may be paired by parameter values. As shown in Tables 2.1 and 2.2, slab nos. 1, 2, and 3 were all constructed without shear reinforcement and serve as baseline slabs for this study. The load-response behavior and failure modes of these three slabs varied. The small amount of principal reinforcement in slab no. 1 allowed flexural failure to occur prior to shear failure. The experiment was terminated when it appeared that the load resistance of the slab was rapidly deteriorating and that collapse was impending. This resulted in the well-defined three-hinge mechanism as shown in the photograph of Figure 3.1.

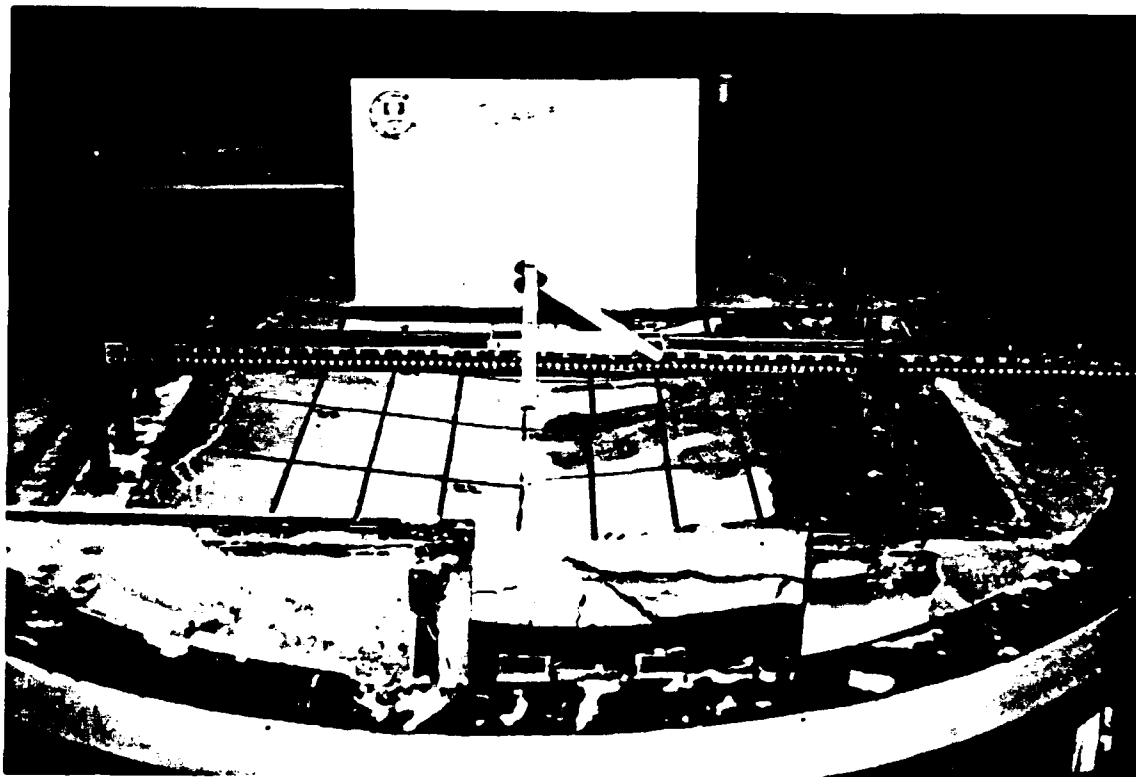
Figure 3.2. Posttest View of Slab No. 2

41. The lack of shear reinforcement in slab no. 2 resulted in a combined flexure-shear failure mode. Figure 3.2 shows the diagonal cracking and separation of the concrete through the thickness of the slab as a result of no shear reinforcement being present to stop the crack propagation. It appears that the larger amount of principal reinforcement (as compared to that in slab

no. 1) prevented the flexural failure until shearing action prevailed.

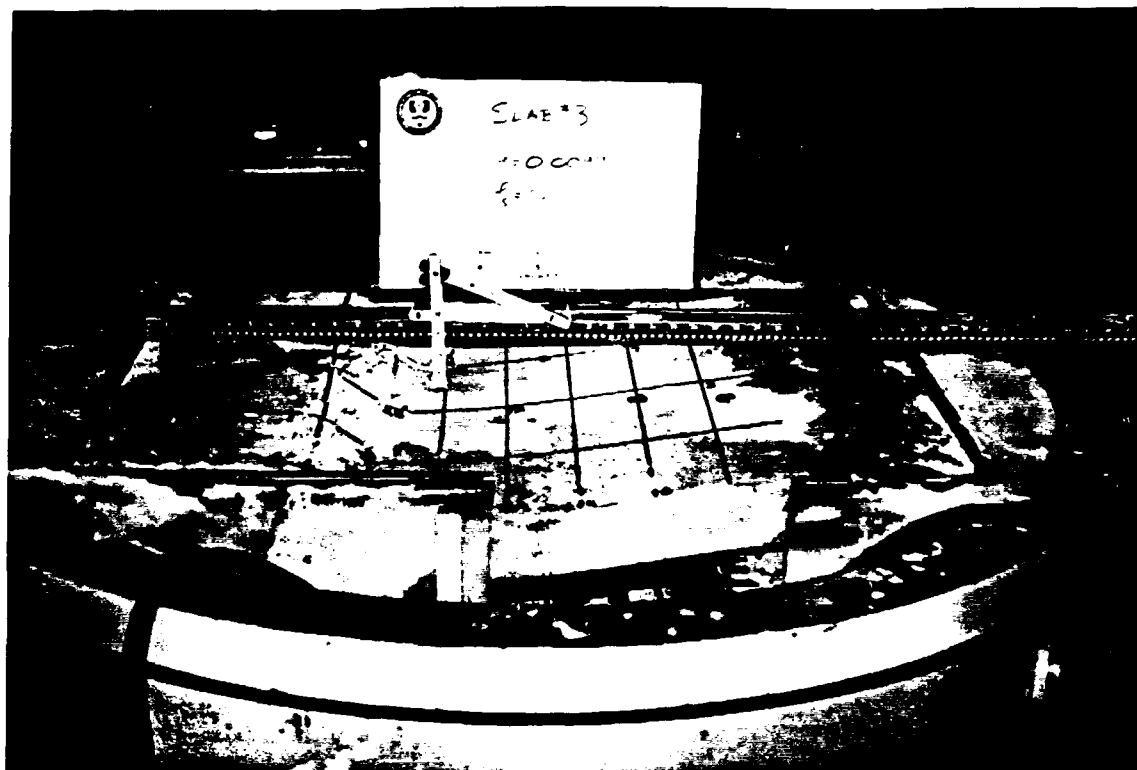
Figure 3.3. Posttest View of Slab No. 3

42. The large principal reinforcement ratio and the lack of shear reinforcement in slab no. 3 resulted in the dominate shear failure shown in Figure 3.3. The three different failure modes of slab nos. 1, 2, and 3 confirm the need for these three baseline experiments in conjunction with the shear reinforcement study.

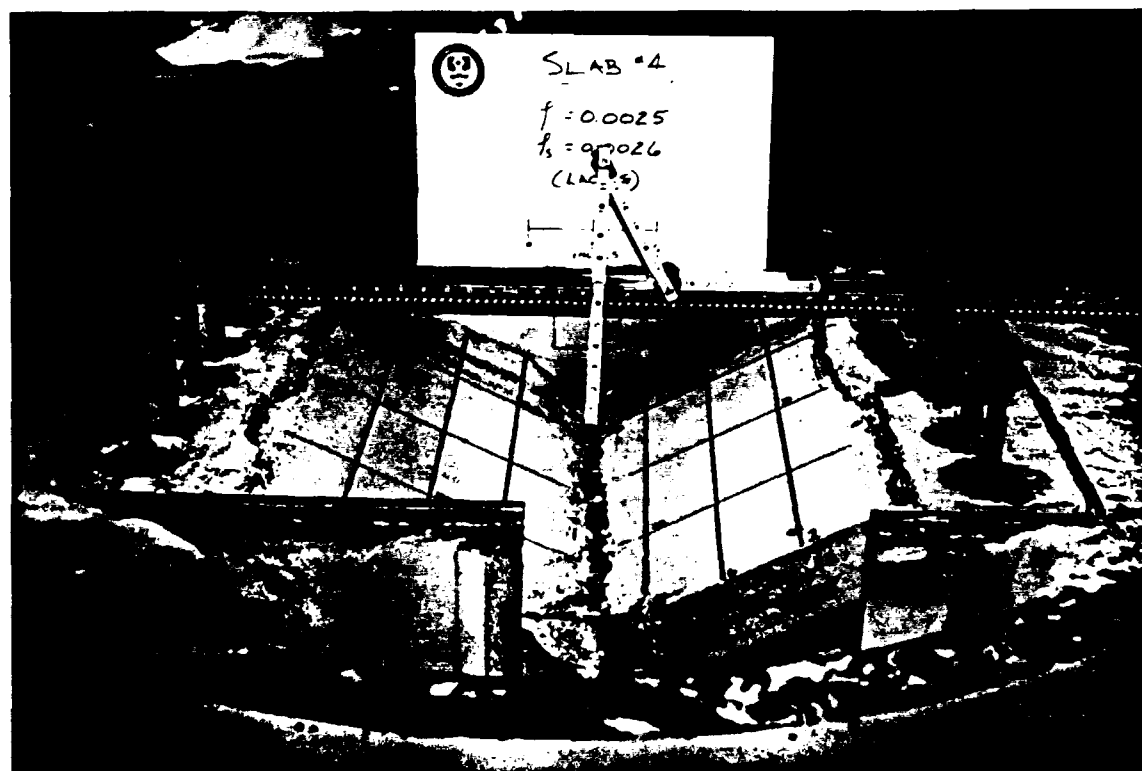
Figure 3.4. Posttest View of Slab No. 4

43. Slab nos. 4 and 10 differed only in the types of shear reinforcement (lacing in slab no. 4 and stirrups in slab no. 10). Figures 3.4 and 3.10 show that both slabs responded in a well-defined three-hinge mechanism, as was in the case for the baseline slab (slab no. 1) corresponding to these two slabs. The posttest measurements indicated that slab no. 4 was pushed slightly further than slab 10 before experiment termination. Both slabs were pushed to support rotations beyond 22 degrees. The extent of concrete cracking was similar for slab nos. 4 and 10. The small amount of shear reinforcement in these two slabs did not significantly alter the response of the slabs as compared to slab no. 1, which was pushed to a support rotation greater than 20 degrees.

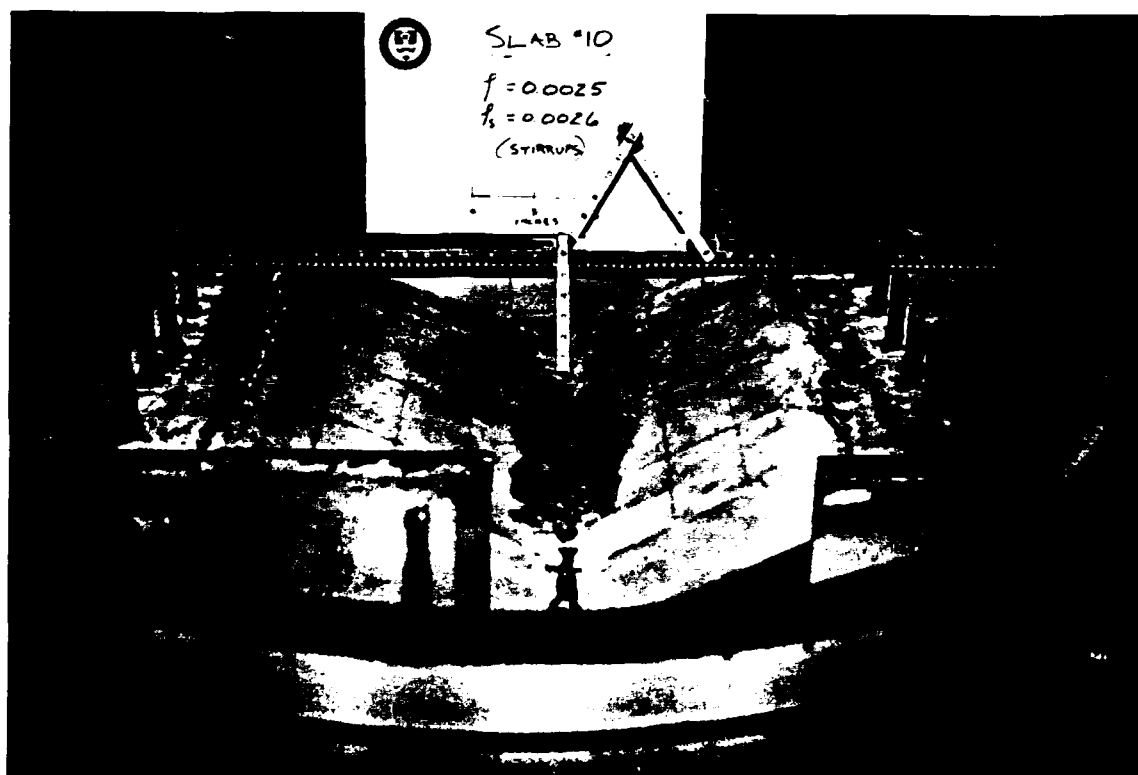
Figure 3.10. Posttest View of Slab No. 10

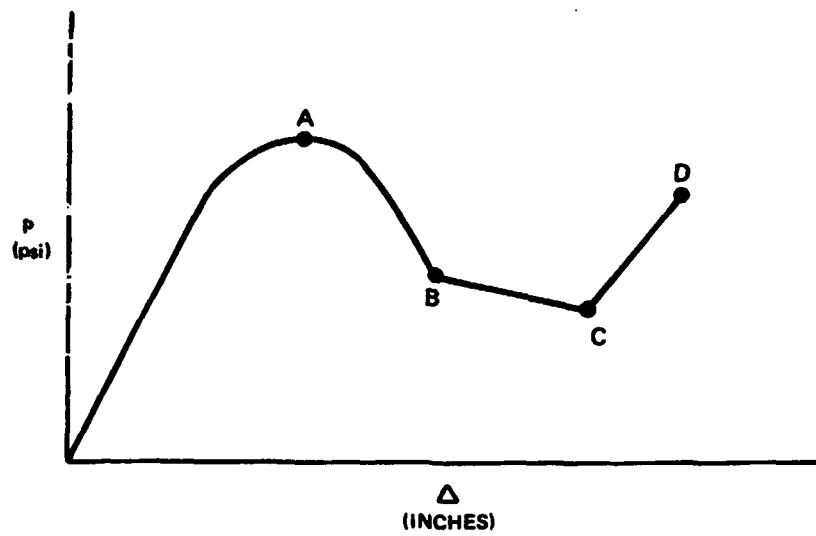
Figure 4.1. General Load-Deflection Curve

36. Figure 4.1 shows the general shape of the midspan load-deflection curve for the slabs as measured with the pressure and deflection gages. Values of load and deflection at points A through D are given in Table 4.1. During the experimental procedure, the decision to terminate an experiment depended upon the trend of the monitored load-deflection curves; therefore, the deflection at termination varied among the slabs. The full load-deflection curves at midspan were not recorded for slab no. 12, 14, and 16 due to a loss of the deflection gage connection (large cracks formed directly at the connection) to the slab during the experiments. However, the load-deflection curves at the one-quarter span location were successfully recorded for slabs 12, 14, and 16 and will be discussed later.

50. The ultimate capacity of a reinforced concrete member is the peak load resistance sustained prior to "snap-through". In this report, the resistance at the point "A" in Figure 4.1 corresponds to the ultimate capacity. The ultimate capacity is enhanced in slabs whose edges are restrained against lateral movement. As the slab deflects, changes in geometry cause the slab's edges to tend to move outward and to react against the stiff boundary elements. The membrane forces enhance the flexural strength of the slab sections at the yield lines. It is generally known that the compressive membrane forces may increase the strength of the slab sections at the yield
